# PEMAC PTE LTD

## SERVICE BULLETIN

Bulletin No: **PPL-SB061**

Subject: **Additional Security for Ball Joint on HawkJaw Push Arms**

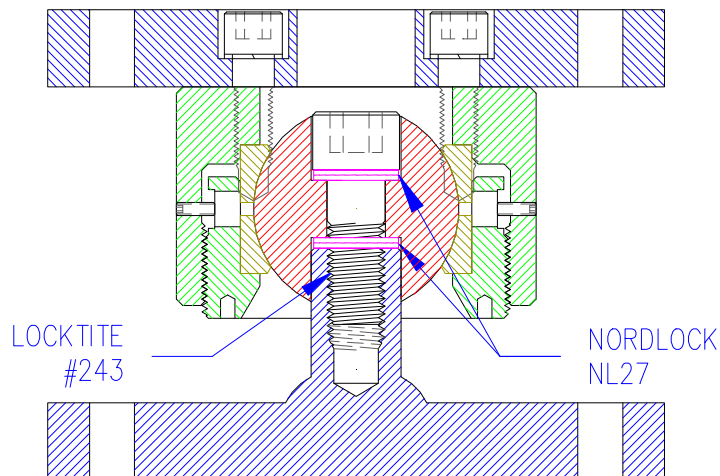
A 1-1/8" capscrew was recently reported to have backed out of ball joint, allowing the support-end of the arm to drop. Service Bulletin PPL-SB051 required a safety lock washer to be installed between ball and pin, to transfer residual torque from the push arm, via bearings, grease and ball, to the ball pin bracket.

Review of field conditions found that safety washers can easily be installed in the 'natural' position, between capscrew and ball, where they are unable to lock the ball to the pin. To avoid mis-assembly, an extra safety lock washer; Nord-Lock p/n NL27 is placed between capscrew and ball as shown. The 1-1/8" capscrew should be installed with Loctite 243 removable threadlocker and torqued to 200 ft lb.

Existing Push Arm Models SPA7-- & SPA9-- should be checked for tightness of the capscrew and for correct position of safety lock washers, when rig operations allow. An additional Nord-Lock washer set is available for free issue to all applicable rigs as listed below.
